# SERVICE BULLETIN

**Product: SL-14**

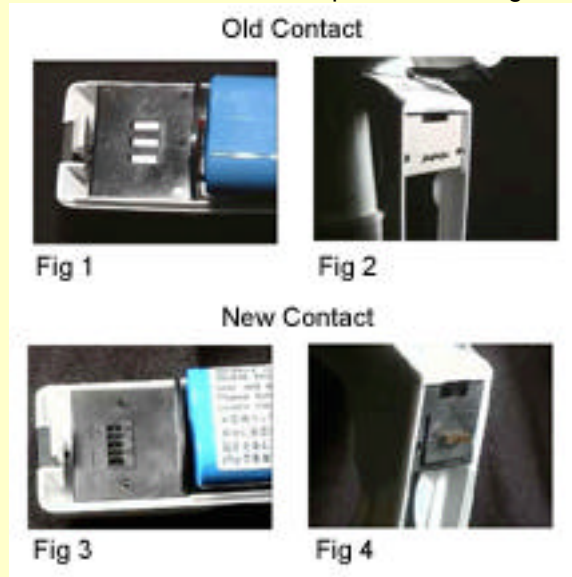
During the recent years of selling the hand held slit lamp SL-14, we noted that the operators sometimes press the battery release tab while the bulb is illuminated. This cause spark on the battery contacts and burned the contact plates resulting to no illumination light.

As shown on Fig.1 and Fig.2 , the electrical contact between the battery and slit lamp is made by 3 spring loaded contact pins on the slit lamp side that are pressed to the contact plates on the battery.

This contacts will be replaced with a 5 pin board connector and socket (Fig.3 and Fig.4). This change will be made on both the Slit Lamp and the Charger base
